**Flood Control Project Maintenance  
Levee Inspections**  
**LMA District Cover Sheet**  
**Spring 2015 Levee Inspection Results**

**Reclamation District No. 2095 Paradise Cut**

**Levee Inspection Report By Mile - Spring 2015**

Waterway	Bank	Unit Miles	Inspection Start/End	Inspector
Unit No. 01 Paradise Cut	Left	1.45	04/22/2015 04/22/2015	Maksim Khashchuk

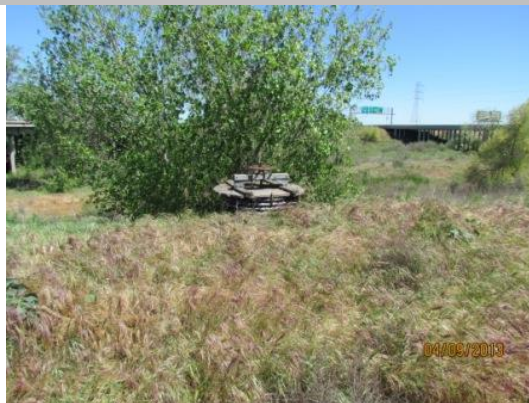
Photo 1 of 1 : SP\_2015\_RD2095\_322\_3\_20150317\_00002.jpg

LM Start	0.07	Rating **	A/W	Issue No.	3
LM End	0.07	Issue Type +	En	Location *	WS
Category	Earthen Levee			GPS Latitude/Longitude	
				Start	End
Item	Encroachments			37.770572 °	37.770572 °
				-121.326283 °	-121.326283 °
DWR ID	DWR_RD2095_01_s _ 2013_3				
Action/Comments					
Pipe

View of the pipe at waterside levee hinge.

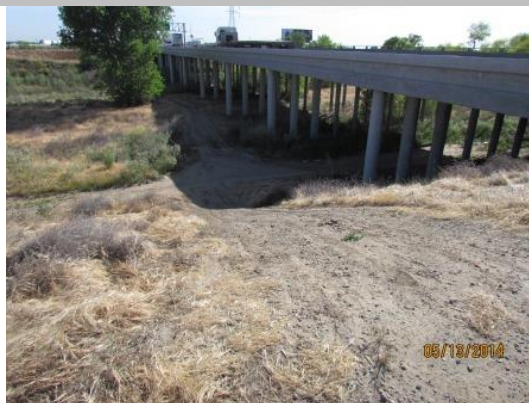
Photo 1 of 1 : SP\_2015\_RD2095\_322\_134\_20150317\_00008.jpg

LM Start	0.11	Rating **	A/W	Issue No.	134
LM End	0.11	Issue Type +	Ma	Location *	WS
Category	Earthen Levee			GPS Latitude/Longitude	
				Start	End
Item	Slope Stability			37.770212 °	37.770212 °
				-121.325675 °	-121.325675 °
DWR ID	DWR_RD2095_01_s _ 2014_134				
Action/Comments					
Repair the levee slope damaged by vehicle traffic and prevent access where possible.

View of the vehicle access on the waterside levee slope.

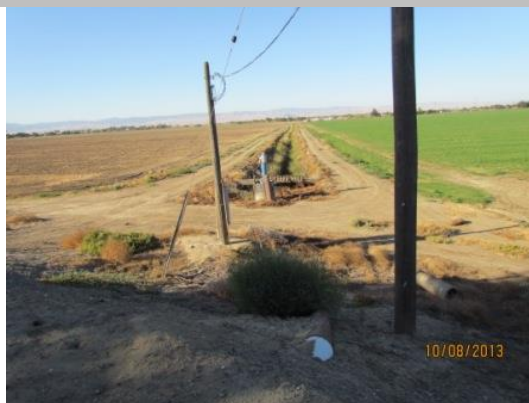
Photo 1 of 2 : SP\_2015\_RD2095\_322\_5\_20150317\_00004.jpg

LM Start	0.35	Rating **	A/W	Issue No.	5
LM End	0.35	Issue Type +	En	Location *	CR
Category	Earthen Levee			GPS Latitude/Longitude	
				Start	End
Item	Encroachments			37.767822 °	37.767822 °
				-121.322835 °	-121.322835 °
DWR ID	DWR_RD2095_01_s _ 2012_5				
Action/Comments					
Pipe					
Inspector Comments: No closure devices or flap gate on discharge pipe. Pipe penetrates freeboard of levee.

View of pipe daylighting at landside levee slope.

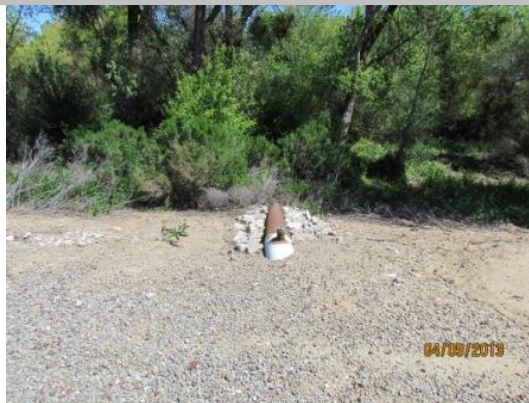
Photo 2 of 2 : SP\_2015\_RD2095\_322\_5\_20150317\_00005.jpg

LM Start	0.35	Rating **	A/W	Issue No.	5 (cont)	
LM End	0.35	Issue Type +	En	Location *	CR	
Category	Earthen Levee			GPS Latitude/Longitude		
				Start		End
Item	Encroachments			37.767822 °	37.767822 °	
				-121.322835 °	-121.322835 °	
DWR ID	DWR_RD2095_01_s _ 2012_5					
Action/Comments						
Pipe						
Inspector Comments: No closure devices or flap gate on discharge pipe. Pipe penetrates freeboard of levee.

View of the pipe penetrating waterside levee slope.

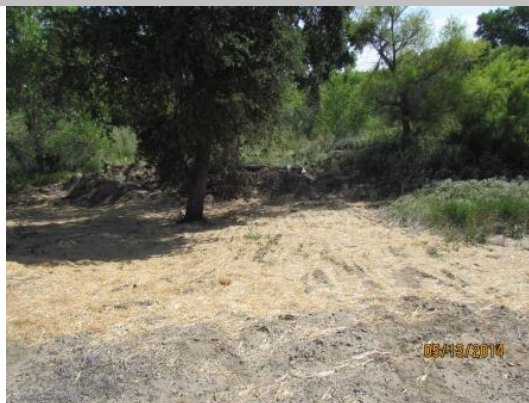
Photo 1 of 1 : SP\_2015\_RD2095\_322\_13\_20150317\_00007.jpg

LM Start	0.42	Rating **	A/W	Issue No.	13
LM End	0.42	Issue Type +	Ma	Location *	WS
Category	Earthen Levee			GPS Latitude/Longitude	
				Start	End
Item	Slope Stability			37.766917 °	37.766917 °
				-121.322267 °	-121.322267 °
DWR ID	DWR_RD2095_01_s _ 2013_13				
Action/Comments					
Repair the levee slope damaged by vehicle traffic and prevent access where possible.					
Inspector Comments: LMA is actively controlling the slope instability.

View of the repaired waterside levee slope.

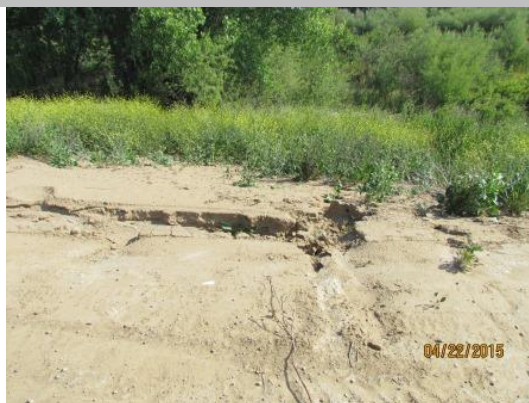
Photo 1 of 1 : SP\_2015\_RD2095\_322\_242\_20150424\_00321.jpg

LM Start	0.68	Rating **	M	Issue No.	242
LM End	0.68	Issue Type +	Ma	Location *	WS
Category	Earthen Levee			GPS Latitude/Longitude	
				Start	End
Item	Erosion / Bank Caving			37.763991 °	37.763991 °
				-121.319334 °	-121.319334 °
DWR ID	DWR_RD2095_01_s _ 2015_242				
Action/Comments					
Schedule repair of erosion site prior to the next inspection.

View of the erosion on the waterside levee hinge.

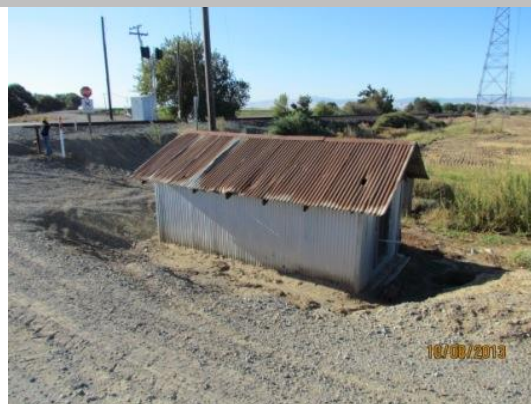
Photo 1 of 1 : SP\_2015\_RD2095\_322\_11\_20150317\_00006.jpg

LM Start	0.71	Rating **	M	Issue No.	11
LM End	0.71	Issue Type +	En	Location *	LS
Category	Earthen Levee			GPS Latitude/Longitude	
				Start	End
Item	Encroachments			37.763630 °	37.763630 °
				-121.319045 °	-121.319045 °
DWR ID	DWR_RD2095_01_s_2012_11				
Action/Comments					
Building					
Inspector Comments: Pump house near RR.

View of building at the landside levee toe.

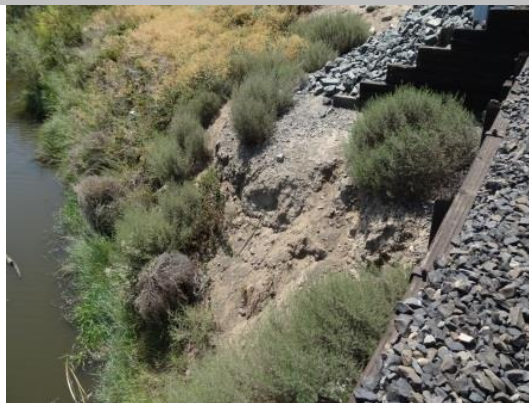
Photo 1 of 1 : SP\_2015\_RD2095\_322\_1\_20150317\_00001.jpg

LM Start	0.72	Rating **	M	Issue No.	1
LM End	0.72	Issue Type +	Ma	Location *	WS
Category	Supplemental			GPS Latitude/Longitude	
				Start	End
Item	DWR Erosion Survey			37.763630 °	37.763630 °
				-121.319000 °	-121.319000 °
DWR ID	DWR_RD2095_01_s _ 2015_1				
Action/Comments					
Inspector Comments: 08/26/2014: No significant change observed. 08/28/2013: No significant change observed. 07/18/2012: No significant change observed. 09/02/2011: No significant change observed. 09/22/2010: No significant change observed. There is now considerable vegetation at the water line and along the lower berm slope. However, the erosion on the lower berm slope is still present and has not been corrected. 08/06/2010: Recommended for local maintenance issue, per CLRO. 07/29/2009: No major change since last visit; noticeable vegetation growth; erosion is on berm, but if left untreated, it will eventually erode into levee prism; site is recommended for annual assessment and monitoring of the site, per CLRO CES 2008 Report; Site # is the same as RM6.80,LM0.73; previously rated "U". 07/22/2008: Downstream of WPRR near siphon pipe & pump; sandy levee; visited by Jeff Van Gilder and LRO in 2008 for repair assessment; scouring downstream of RR crossing, possibly caused by eddy effects. 03/13/2007: Site visited on 03/13/2007. [2014 Site ID:RD2095U01RM6.74]

Direct view of the erosion upstream of Railroad bridge.

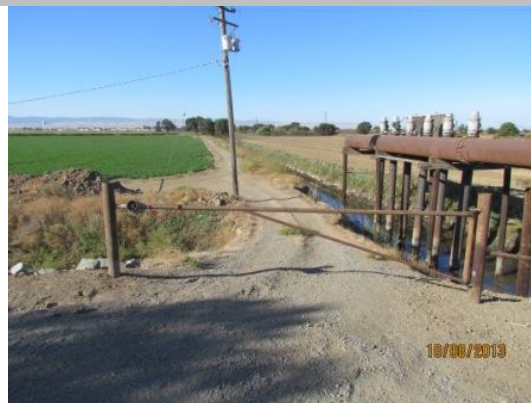
Photo 1 of 1 : SP\_2015\_RD2095\_322\_4\_20150317\_00003.jpg

LM Start	0.88	Rating **	A/W	Issue No.	4
LM End	0.88	Issue Type +	En	Location *	LS
Category	Earthen Levee			GPS Latitude/Longitude	
				Start	End
Item	Encroachments			37.761475 °	37.761475 °
				-121.317804 °	-121.317804 °
DWR ID	DWR RD2095 01 f 2013 4

Action/Comments					
Fence Inspector Comments: Permitted gate across landside levee ramp. A key was provided to the DWR inspector.

View of the new gate at landside levee hinge.

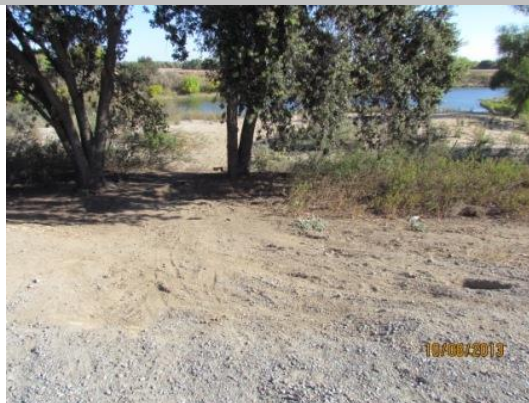
Photo 1 of 1 : SP\_2015\_RD2095\_323\_9\_20150317\_00006.jpg

LM Start	0.03	Rating **	A/W	Issue No.	9
LM End	0.03	Issue Type +	Ma	Location *	WS
Category	Earthen Levee			GPS Latitude/Longitude	
				Start	End
Item	Slope Stability			37.758986 °	37.758986 °
				-121.307854 °	-121.307854 °
DWR ID	DWR_RD2095_02_s _ 2013_9				
Action/Comments					
Repair the levee slope damaged by vehicle traffic and prevent access where possible.

View of the vehicle tire ruts on waterside levee slope.

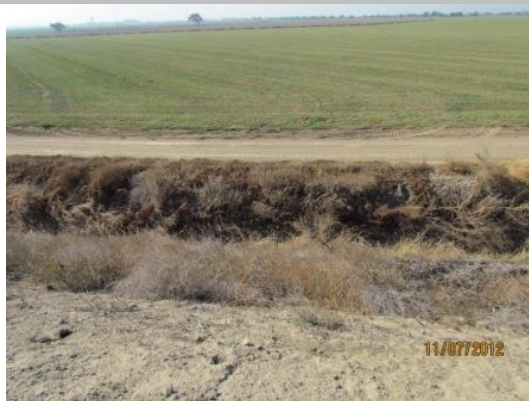
Photo 1 of 1 : SP\_2015\_RD2095\_323\_5\_20150317\_00004.jpg

LM Start	0.36	Rating **	M	Issue No.	5
LM End	0.82	Issue Type +	En	Location *	LS
Category	Earthen Levee			GPS Latitude/Longitude	
				Start	End
Item	Encroachments			37.754952 °	37.749645 °
				-121.305880 °	-121.301977 °
DWR ID	DWR_RD2095_02_f _ 2012_5				
Action/Comments					
Ditch

View of a ditch along the landside toe.

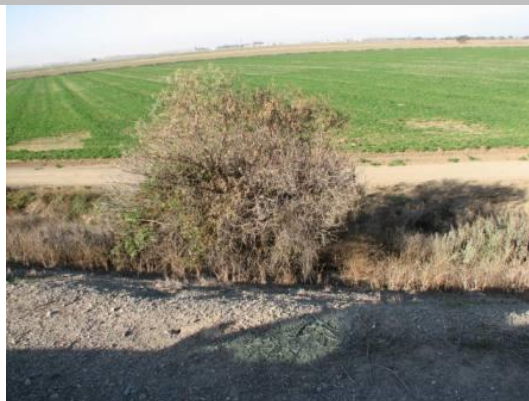
Photo 1 of 1 : SP\_2015\_RD2095\_323\_6\_20150317\_00005.jpg

LM Start	0.60	Rating **	A/W	Issue No.	6
LM End	0.60	Issue Type +	Ma	Location *	LS
Category	Earthen Levee			GPS Latitude/Longitude	
				Start	End
Item	Vegetation			37.751668 °	37.751668 °
				-121.304302 °	-121.304302 °
DWR ID	DWR_RD2095_02_s _ 2012_6				
Action/Comments					
Elderberries are blocking visibility and flood fight capability.

11/01/2011 Elderberry bush at landside toe.

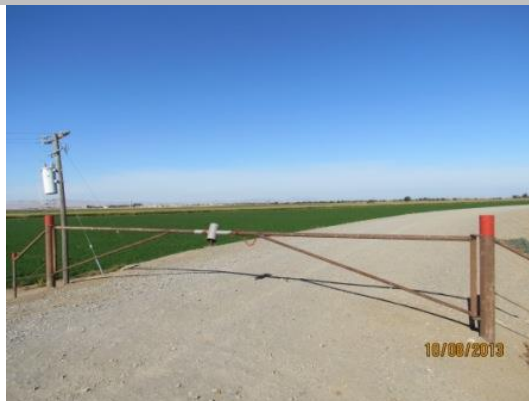
Photo 1 of 1 : SP\_2015\_RD2095\_323\_14\_20150317\_00007.jpg

LM Start	0.74	Rating **	A/W	Issue No.	14
LM End	0.74	Issue Type +	En	Location *	LS
Category	Earthen Levee			GPS Latitude/Longitude	
				Start	End
Item	Encroachments			37.749916 °	37.749916 °
				-121.303312 °	-121.303312 °
DWR ID	DWR_RD2095_02_f_2013_14				
Action/Comments					
Fence					
Inspector Comments: Permitted gate across levee crown. A key was provided to the DWR inspector.

View of new gate across levee crown.

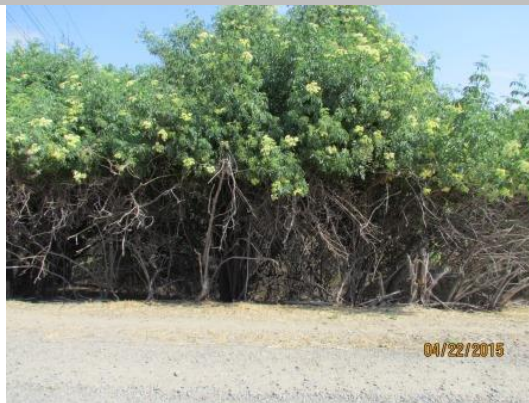
Photo 1 of 2 : SP\_2015\_RD2095\_323\_941\_20150424\_00553.jpg

LM Start	0.97	Rating **	A/W	Issue No.	941
LM End	0.97	Issue Type +	Ma	Location *	WS
Category	Earthen Levee			GPS Latitude/Longitude	
				Start	End
Item	Vegetation			37.749706 °	37.749706 °
				-121.299237 °	-121.299237 °
DWR ID	DWR_RD2095_02_s _ 2012_941				
Action/Comments					
Elderberries are blocking visibility and flood fight capability. Inspector Comments: Dense bush within 20' of crown on waterside slope.

View of the elderberry shrubs at the waterside levee hinge.

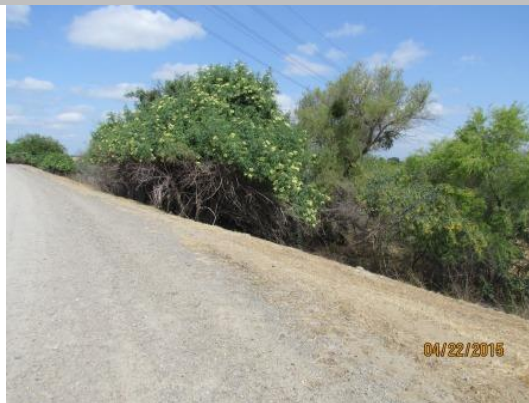
Photo 2 of 2 : SP\_2015\_RD2095\_323\_941\_20150424\_00554.jpg

View of the elderberry shrubs on the waterside levee slope.

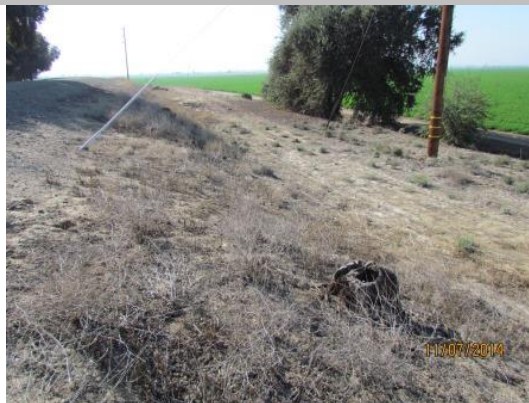
Photo 1 of 1 : SP\_2015\_RD2095\_323\_3\_20150317\_00003.jpg

LM Start	1.09	Rating **	N	Issue No.	3
LM End	1.09	Issue Type +	Ma	Location *	LS
Category	Earthen Levee			GPS Latitude/Longitude	
				Start	End
Item	Trim / Thin Trees			37.748184 °	37.748184 °
				-121.298995 °	-121.298995 °
DWR ID	DWR_RD2095_02_s_2012_3				
Action/Comments					
Tree stumps.					
Inspector Comments: 4 stumps

View of the tree stumps on the landside levee slope..

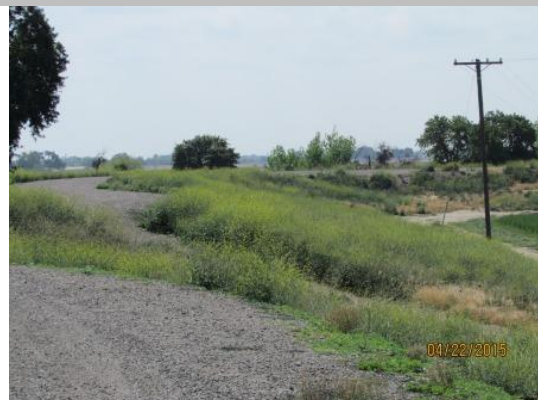
Photo 1 of 1 : SP\_2015\_RD2095\_323\_365\_20150424\_00555.jpg

LM Start	1.51	Rating **	U	Issue No.	365
LM End	1.51	Issue Type +	Ma	Location *	LS
Category	Earthen Levee			GPS Latitude/Longitude	
				Start	End
Item	Vegetation			37.742866 °	37.742866 °
				-121.297274 °	-121.297274 °
DWR ID	DWR_RD2095_02_s _ 2015_365				
Action/Comments					
Control annual grass and weeds on the levee slopes and easements. Inspector Comments: Dense vegetation on levee slope.

View of the annual vegetation on the landside levee slope.

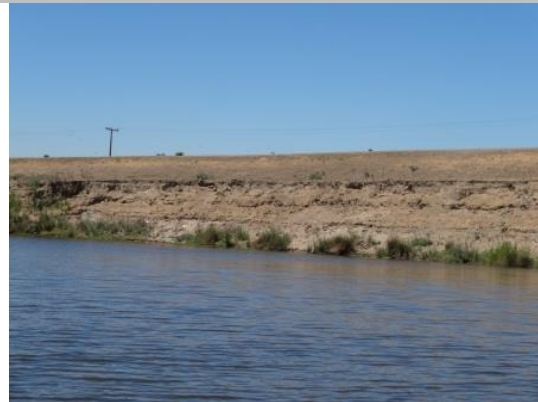
Photo 1 of 1 : SP\_2015\_RD2095\_323\_1\_20150317\_00001.jpg

Action/Comments					
Inspector Comments: 7/02/2014: No significant change observed. 08/28/2013: No significant change observed. 09/13/2012: The site has been visited by land survey. The vegetation on the site shows the erosion has not developed significantly from the last survey. The site was not visited by boat survey due to the limitation of navigable waterway. 08/23/2011: No significant change observed. 9/22/2010: No significant change observed. There is moderate vegetation growth on the berm. Despite the erosion occurring on the berm, corrective action should be taken before the issue becomes severe. 9/29/2009: Site is immediately downstream of a section of existing rip rap; there is a 20-foot berm remaining; berm will continue to erode unless erosion is mitigated; Site# is the same as RM62.6, LM1.87; recommended for annual assessment, per CES Evaluation 2008 Report 2006: Visited 10/20/06 [2014 Site ID:RD2095U02RM60.62]

View of the erosion.

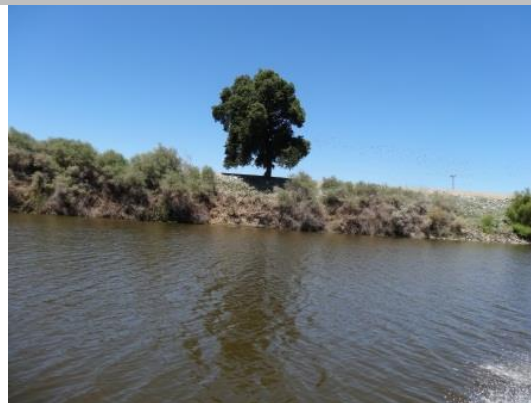
Photo 1 of 1 : SP\_2015\_RD2095\_323\_2\_20150317\_00002.jpg

Inspector Comments: 7/02/2014: No significant change observed.  
08/28/2013: No significant change observed. Dense vegetation blocks the visual inspection at the site.  
09/13/2012: The site has been visited by land survey. The erosion is not visible from the levee slope because of dense vegetation at the site. Levee slope is protected by placed rocks. The site was not visited by boat survey due to the limitation of navigable waterway.  
08/23/2011: Dense vegetation makes it difficult to view the possible erosion. No new development was observed on site.  
09/23/2010: At the time of the inspection, the erosion site was difficult to view from the levee. The erosion is located on the bank toe, below the existing rip rap. There were no signs of repair on site, nor has the site been reported to be repaired by the district. Images taken from last year indicate that existing rip rap at the bank toe has sloughed exposing the underlying soils. Weakening of the toe could lead to future bank instability.

08/05/2010: Recommended for annual assessment and monitoring during flood events, per CLRO.  
09/29/2009: No major change observed since last visit; sloughing of the rip rap above toe; erosion begins immediately downstream of existing rip rap revetment; roughly 15-foot berm remains; however, it will continue to erode and eventually intrude into the levee profile if left untreated.  
10/20/2006: Just upstream of where berm starts to widen. [2014 Site ID:RD2095U02RM60.69]

View of the erosion from the survey boat. The dense vegetation on the site blocks the view of the erosion.

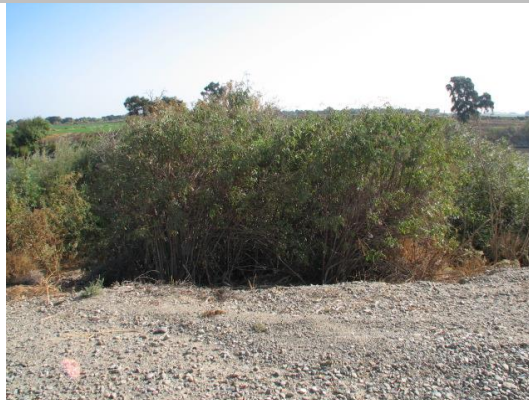
Photo 1 of 1 : SP\_2015\_RD2095\_323\_20\_20150317\_00008.jpg

LM Start	2.12	Rating **	M	Issue No.	20
LM End	2.12	Issue Type +	Ma	Location *	WS
Category	Earthen Levee			GPS Latitude/Longitude	
				Start	End
Item	Vegetation			37.734858 °	37.734858 °
				-121.297758 °	-121.297758 °
DWR ID	DWR_RD2095_02_s_2012_20				
Action/Comments					
Elderberries are blocking visibility and flood fight capability.

Vegetation on waterside slope obstructs access and visibility.
